SPONSOR: **Barrier Fencing Systems**
Saskatoon, Saskatchewan, Canada

Sound Transmission Loss
RAL™-TL22-066

ON: 3inch Barrier Fence System (EPS board insulation 26ga. steel cladding and SMP finish)

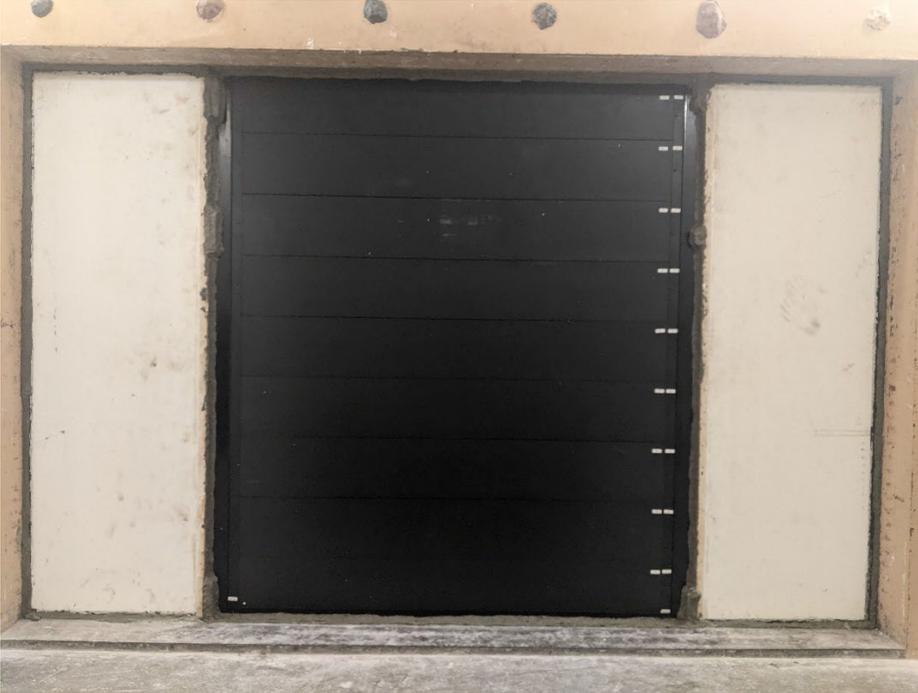
Figure 1 – Specimen mounted in test opening, as viewed from source room

Opening Size: 2.74 m (9.0 ft.) by 4.27 m (14.0 ft.)
Filler Wall: Yes
Aperture Size: 2.43 m (95.75 in) wide by 2.74 m (108.0 in) high
Transmission Area: 6.672 m² (71.81 ft²)
Sealed: Entire periphery (both sides) with dense mastic

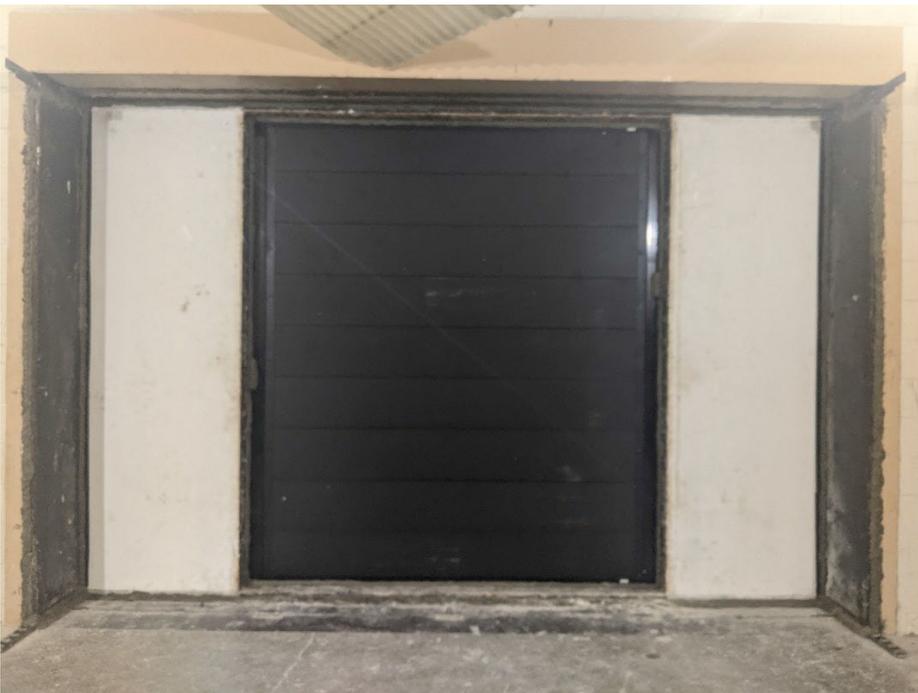
Figure 2 – Specimen mounted in test opening, as viewed from receive room

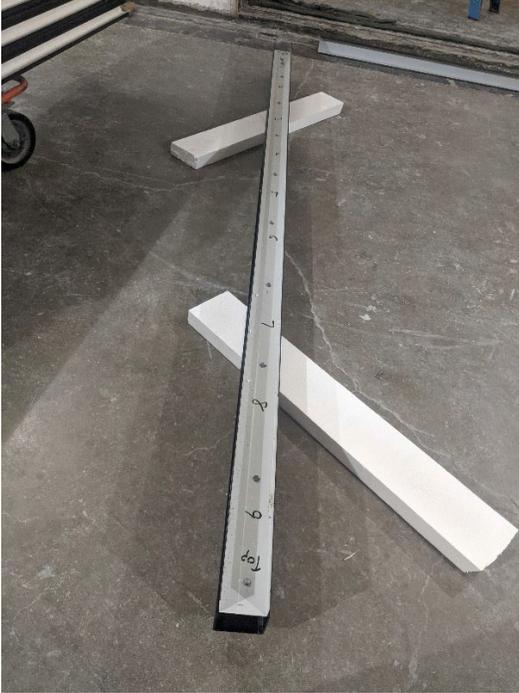
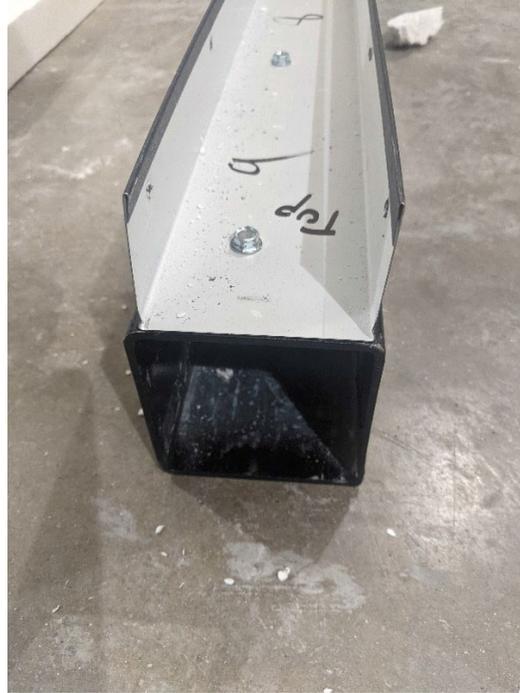
Figure 3 – Test specimen frame piece

Materials: Metal
Thickness: 89 mm (3.5 in.)
Overall Weight: 52.84 kg (116.5 lbs)

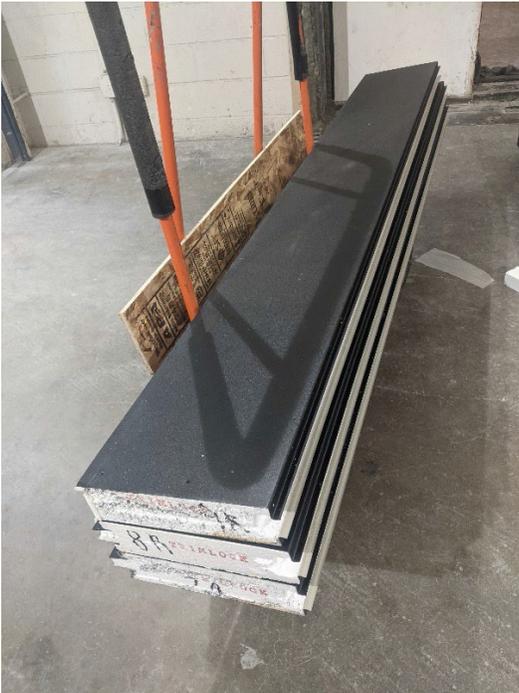
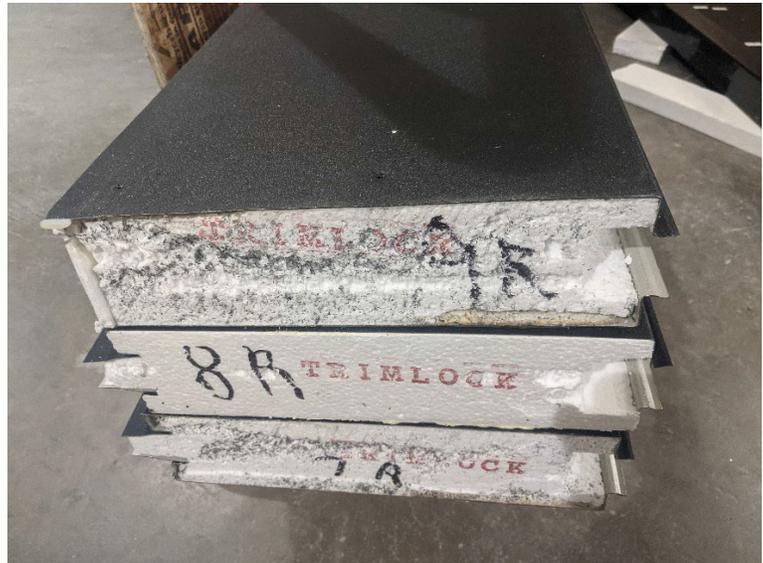
Figure 4 – Test specimen planks prior to installation

Materials: EPS board, metal cladding
Dimensions: 9 planks @ 2248 mm (88.5 in.) by 305 mm (12 in.)
Thickness: 76 mm (3 in.)
Overall Weight: 82.33 kg (181.5 lbs)
Installation: Fit into metal framing pieces

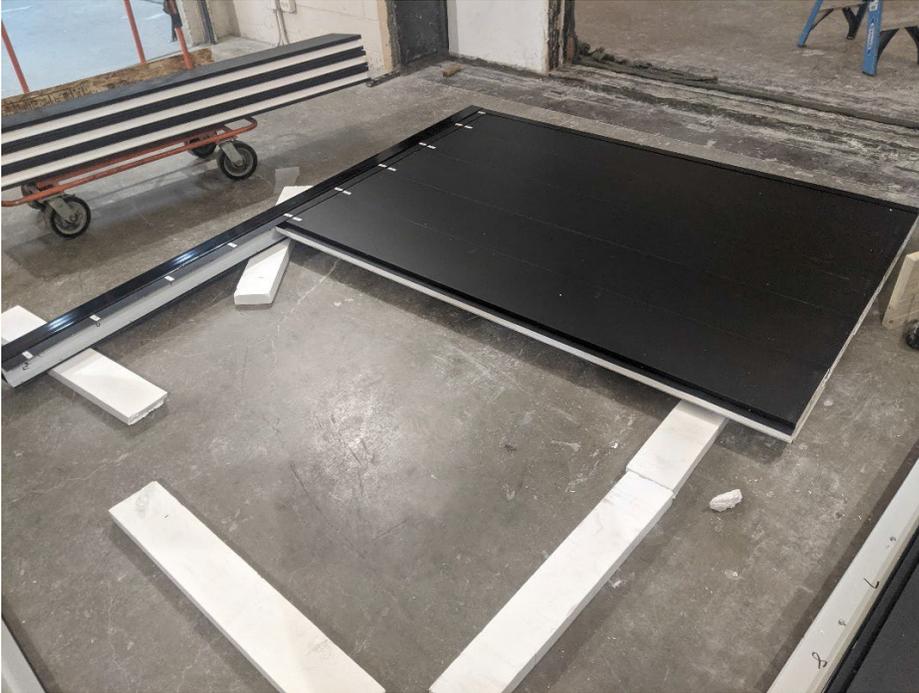
Figure 5 – Test specimen planks fit into framing

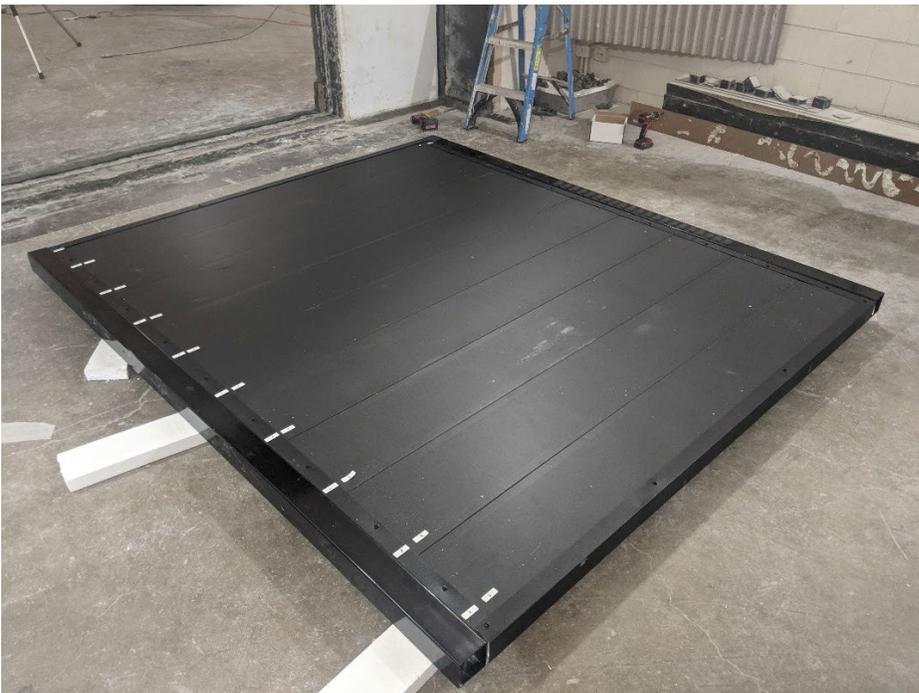
Figure 6 – Test specimen assembled, prior to installation in test aperture

Dimensions: 2.43 m (95.75 in) wide by 2.74 m (108.0 in) high
Thickness: 89 mm (3.5 in.)
Weight: 135.17 kg (298.0 lbs)
Overall Area: 6.672 m² (71.81 ft²)
Mass per Unit Area: 20.26 kg/m² (4.15 lbs/ft²)
